Jack Werner, Phd., Lic#70000255
3625 N. McKinley Ave. OKC, OK 73118-3250

This Building Inspection Has Been Prepared Exclusively For:

Inspection Property is	Commercial	Approx Age	1973	Stories	1
Approx Sq Ft	54,033	Occupancy	Vacant	Building faces	West

Summary Evaluation/Repairs Needed Before Closing	
Note: We Do Not Test For Mold, Lead, Asbestos, Or Radon Unless Specifically Contracted	
Description	Estimate

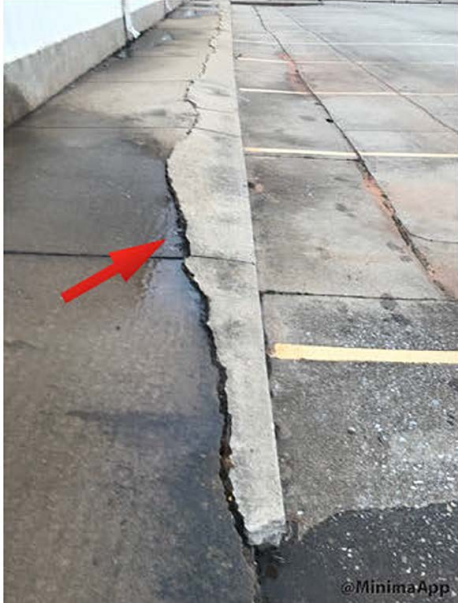
#	Description	Estimate
	The main building appears to have typical settlement for its age.	
104	On the S. Side of the main building there are signs of what is called street creep-concrete creep. This is caused from vehicles turning around and in doing so pushing the street/parking lot toward the building. This has caused the side walk on the N. Side of the building to buckle. This situation needs to be properly immediately repaired before it does effect the building. Have a professional evaluation and repair. (See Exterior 2.0 about repairing the concrete.)	5200 to 6500
112 114	Warehouse/building G: the concrete stem wall has sections broken out in spots around the building. This has exposed the rebar in the stem wall. These areas need to be properly repaired. Inside there is damaged metal framing to the N. Wall. The trust framing has some loose tie downs/anchor points that should be connected to the roof framing. You need a metal building specialist to evaluate all the metal framing and properly repair and replace the framing as needed.	5000 to 7500

Street creep on the South side of the main building.

FYI	Vesta foundations came out to look at the street creep. They have systems that may help mitigate the street creep.	
Total Structural Repair And Evaluation Estimate		\$10200 to \$14000

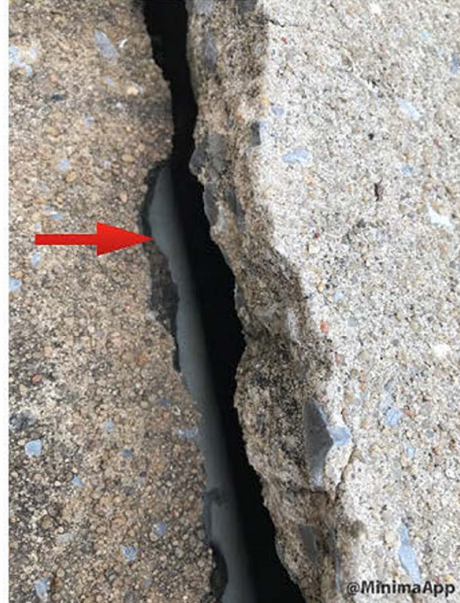
Close up view of the street creep on the South side of the building.

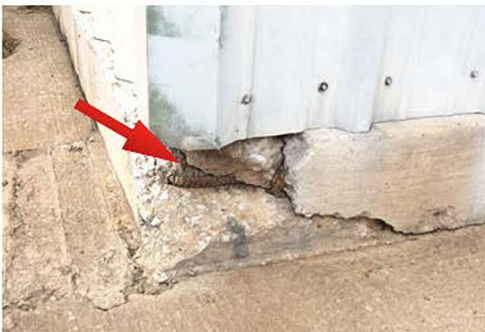
Foundation corner pop with exposed rebar on warehouse

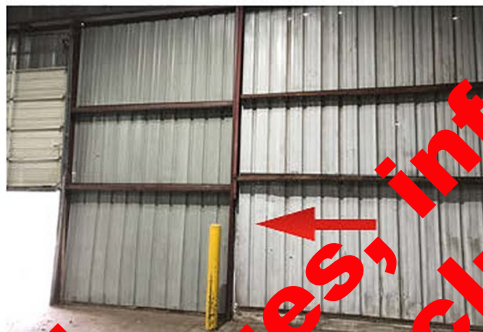
Dem Sed N. Wall framing of warehouse

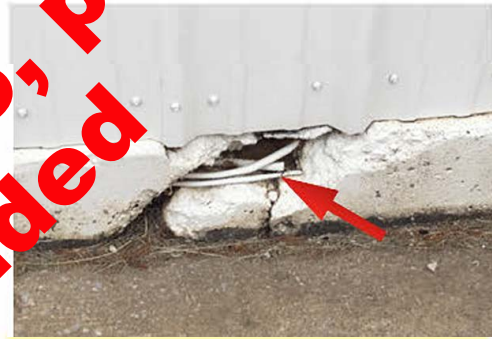
Rebar exposed on warehouse stem wall

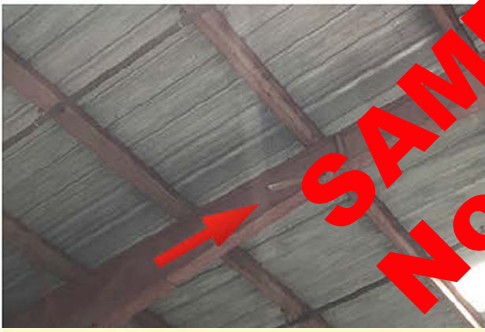
Loose truss anchor for roof framing

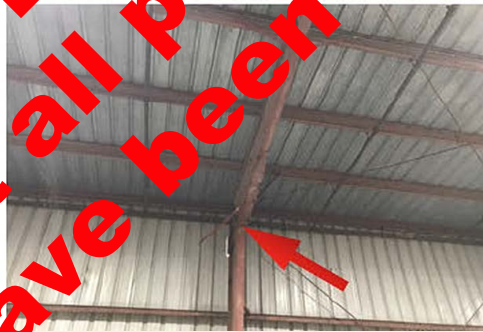
Another loose truss framing

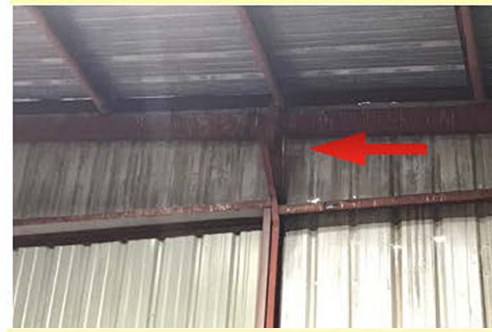
More damaged framing on the N. Wall

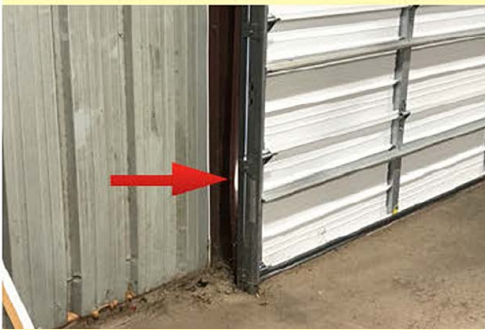
Damaged framing by S. Overhead door of warehouse

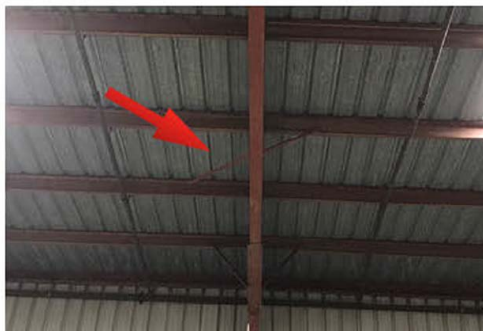
Loose truss anchor for roof framing

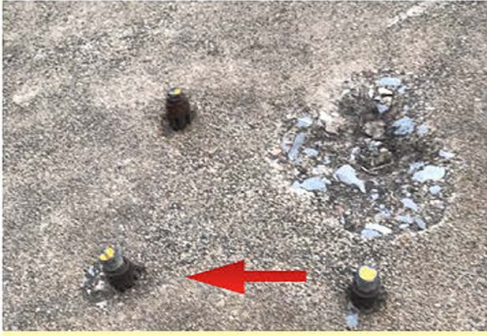
Example of a trip hazard, rebar was not cut flush with the ground.

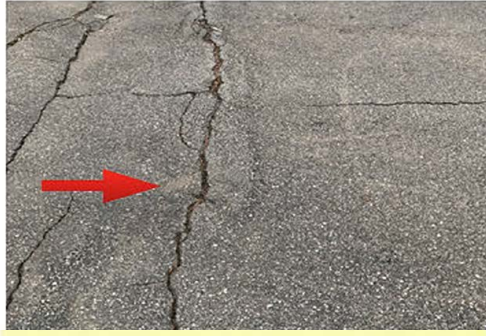
Example of damaged concrete.

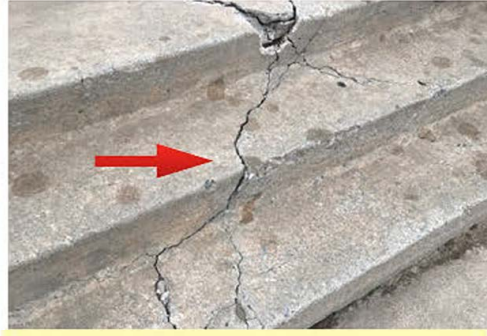
224 227 233	Stairs - there are wood steps on the north side that appear to be temporary and are not properly secured, temporary concrete steps that are irregular in height, and permanent concrete steps which are broken & missing handrails. Some of the handrails have been removed, and others don't exist. Remove the temporary stairs and replace with permanent stairs and add handrails for all the exterior steps.	1300 to 2500
242	There are missing loading dock door bumpers on nearly all but 2 dock doors that need to be replaced. Additionally, the wood acting as a bumper on the South side of the main building is damaged & should be replaced.	2500 to 3500
217 218	All the joints on the West side need to be resealed.	2000 to 3000
205	Building G has significant damage including dented & punctured walls, holes in the walls and indications of animal infestation. The building needs to be sealed to prevent wind & water from getting inside. There are also indications of animal infestation in the main building indicating the metal panels are not properly secured. Cost included above.

Example of damaged stairs.

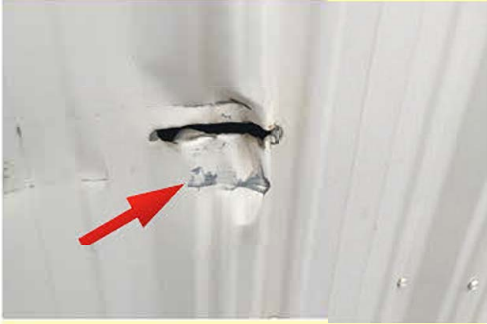
Example of puncture in exterior wall.

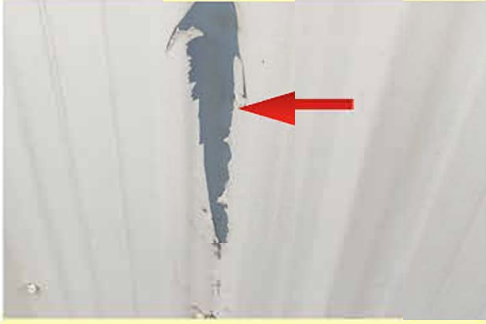
Example of damaged exterior wall that needs paint.

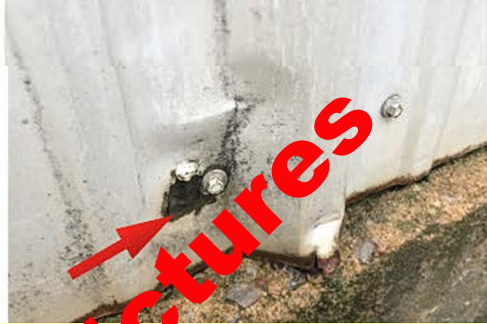
Example of dented exterior siding

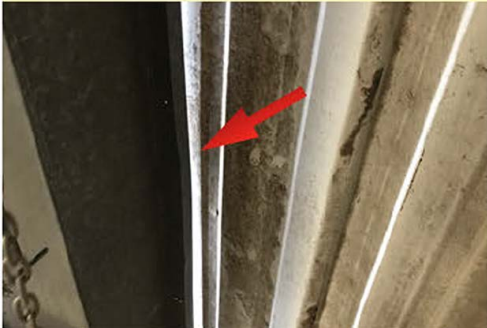
West side by dock door - metal siding not attached & allowing

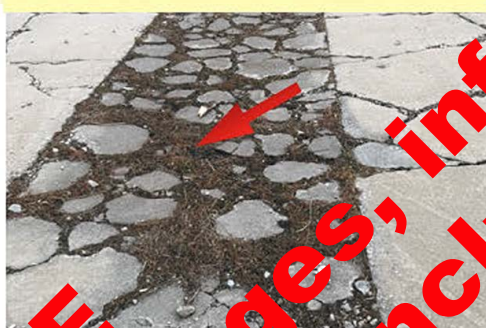
Example of damaged concrete in parking lot

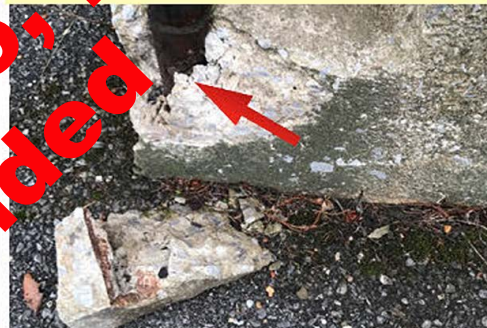
Example of concrete corner pop

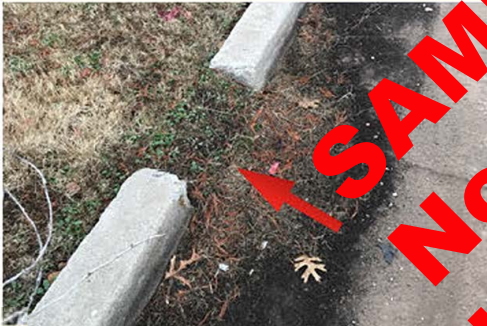
Example of improper landscaping

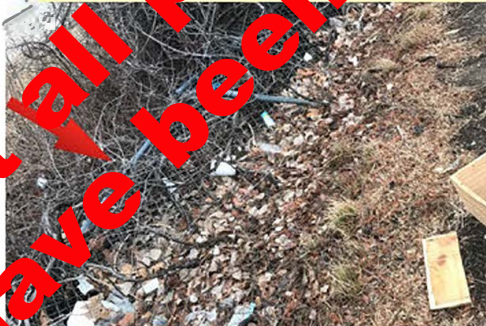
Example of fence that fell over.

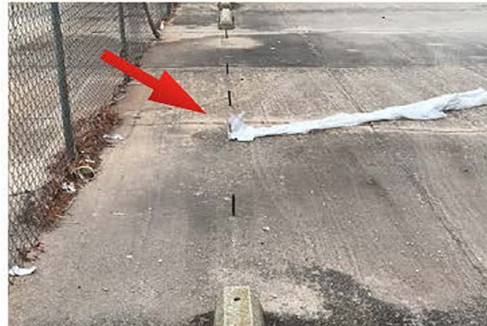
Example of missing parking curbs.

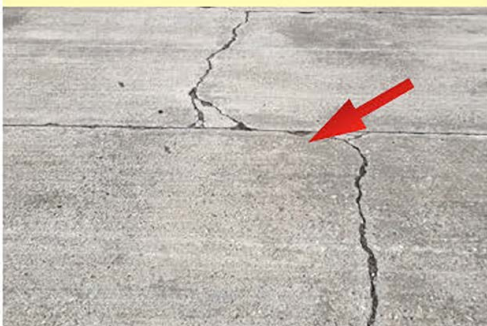
Example of damaged parking lot.

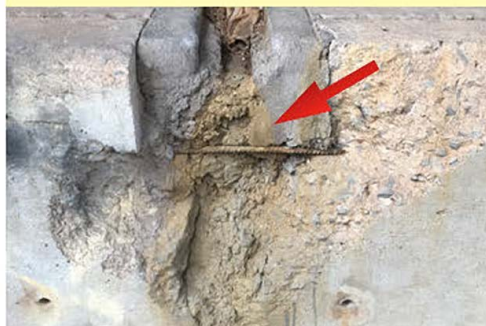
Example of damaged concrete.

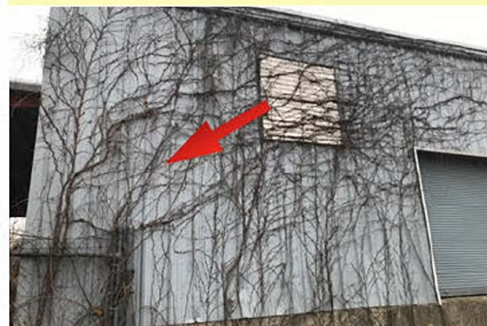
Example of vegetation on the building.

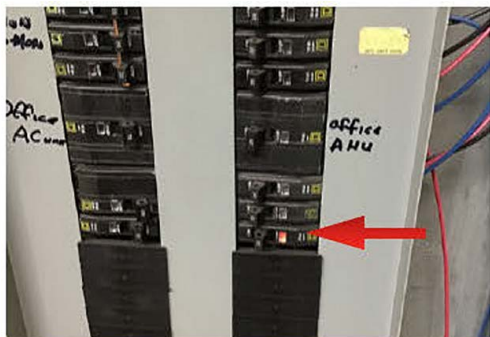
Tripped breaker in panel F

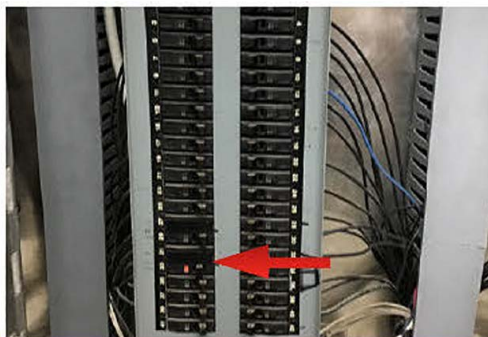
Tripped breaker in panel C

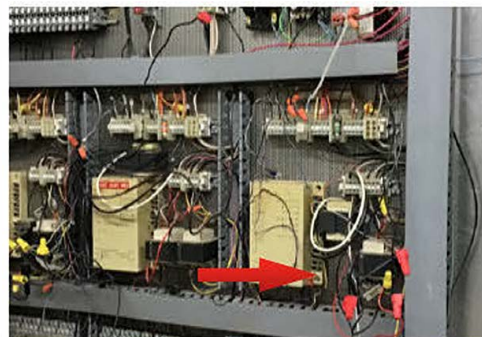
Multiple loose hot wires in thermostat control panel

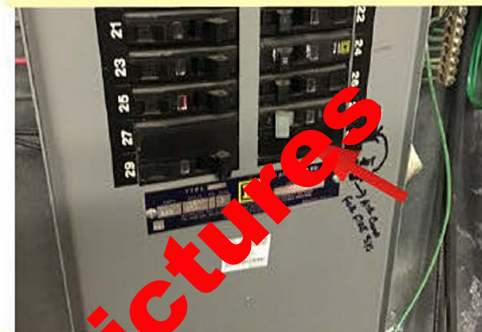
Lock out needed on fire suppression breaker

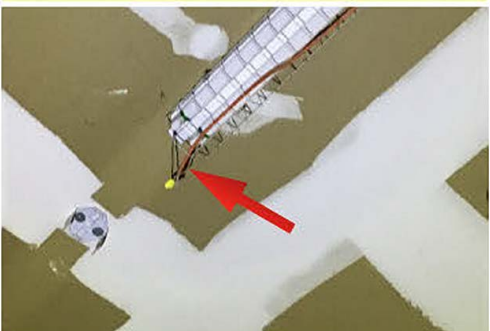
Fluorescent light in suite F powered by extension cord

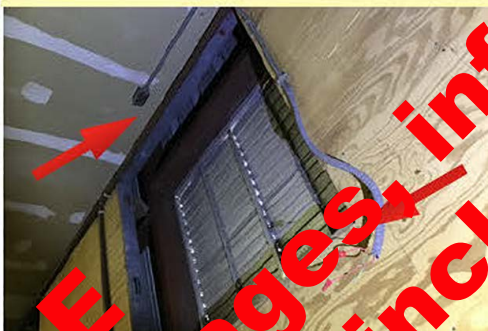
Loose wires and missing cover in suite F

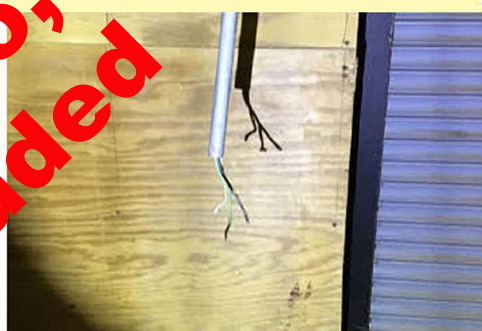
Loose wires in suite F

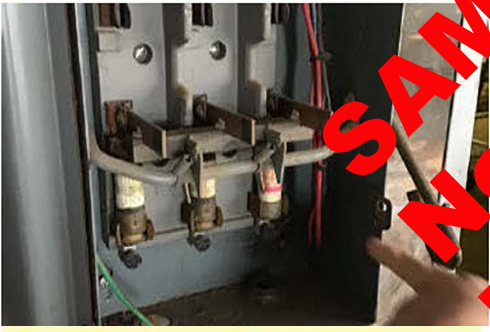
Shutoff box not being used outside of suite F

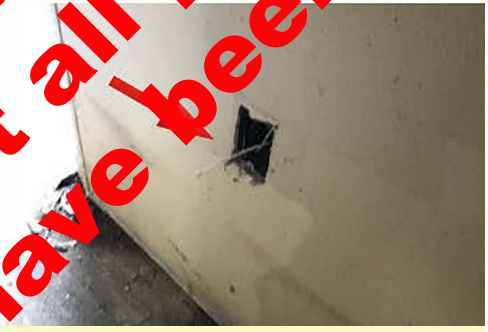
Loose wiring in Suite G

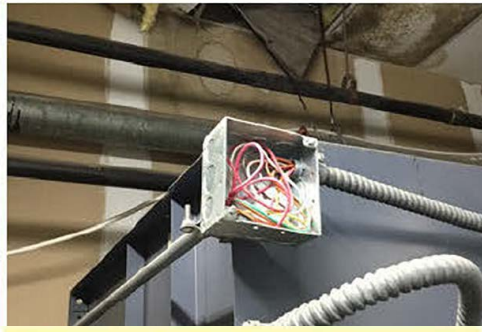
Example of open junction boxes in AHU mechanical room

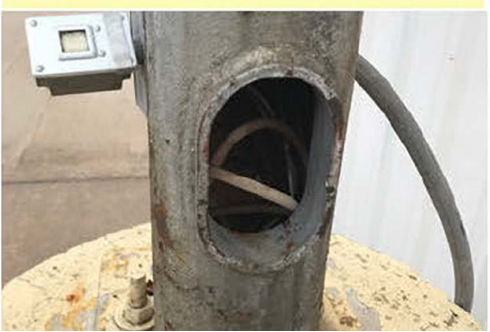
Missing access panel on exterior light pole.

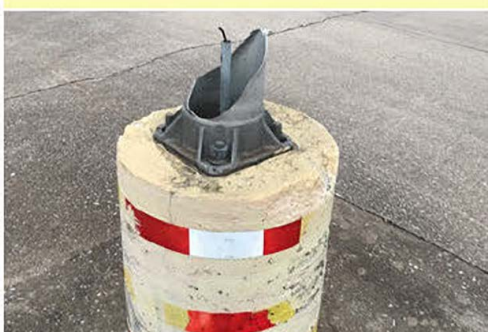
Light pole that is broken off at the base.

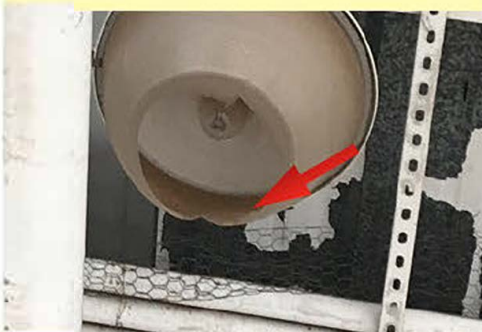
Exterior light with broken cover.

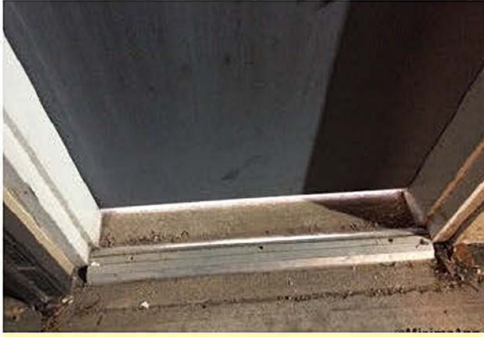
Suite G exterior door not weather tight.

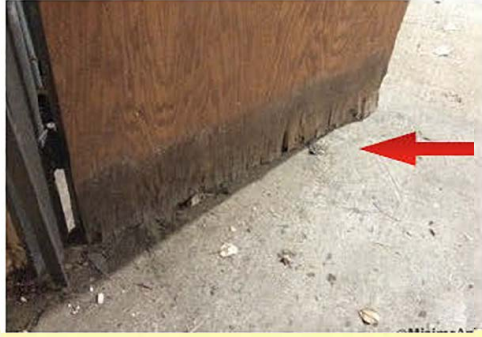
Door to warehouse in suite G delaminated.

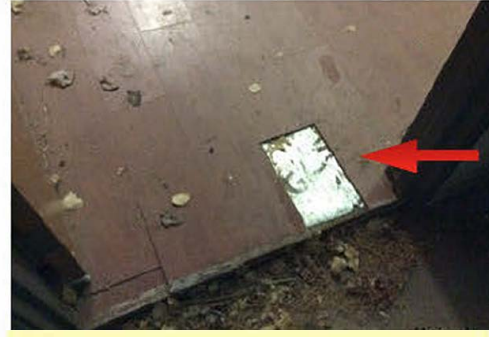
Laminate floor missing and damaged in suite G.

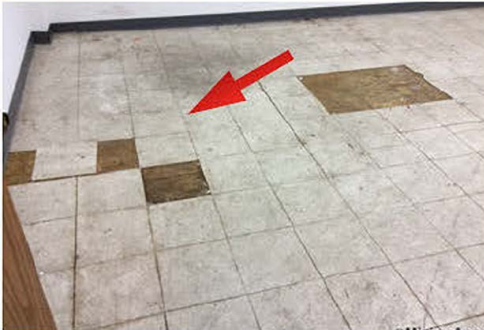
Vinyl floor tiles missing in bathroom in suite G.

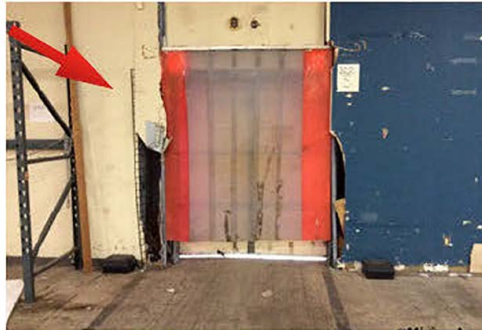
Damaged wall around suite b overhead door.

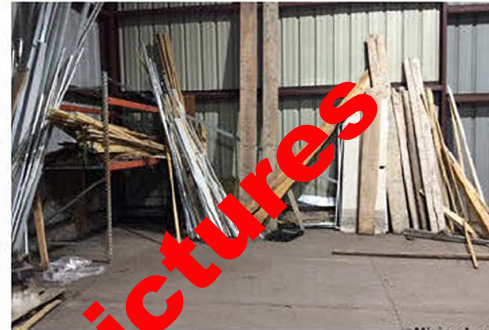
Example of inspection restrictions in suite G.

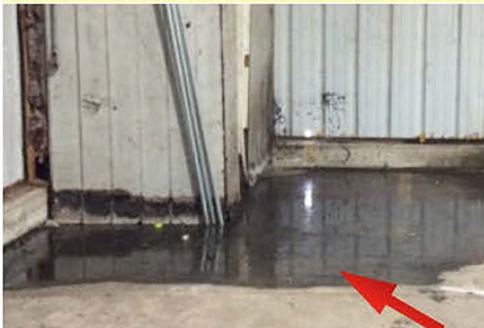
Flooding and mildew like substance in suite G

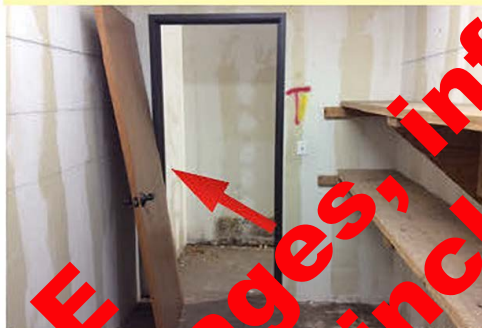
Door off its hinges in Suite G.

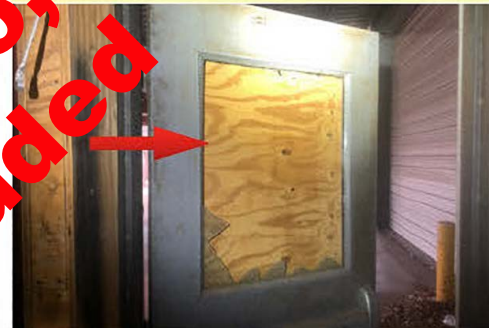
Boarded up, broken window in exterior door of suite F.

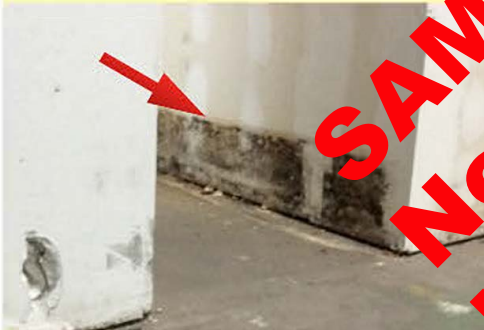
Example of mildew like substance in suite G.

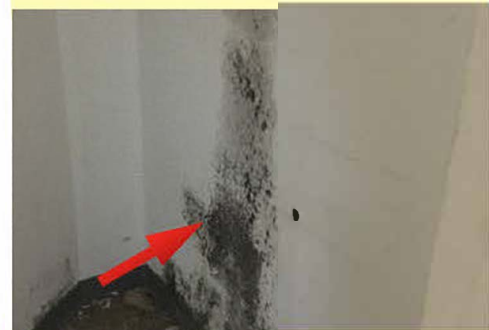
Mildew like substance SW of main entry doors

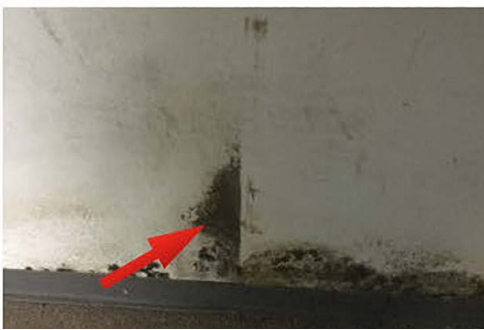
Mildew like substance SW room of entry door

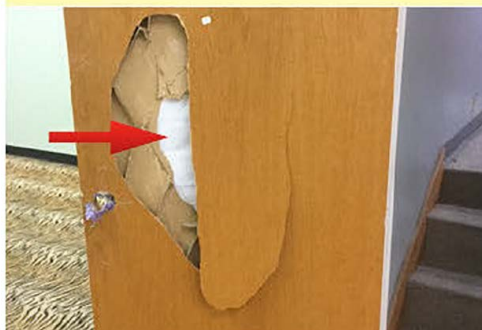
Example of damaged door, SW of entry doors

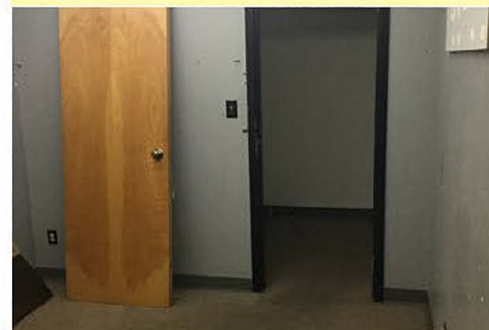
Door removed
